## Case Study

### MorSafe™ technology extends life of asset

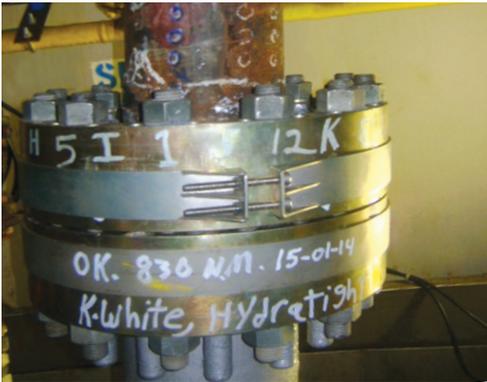
**Above** Hydratight's MorSafe™ 6" CL1500 Flange Clamp solution

Hydratight provided a simple, safe and secure solution using its MorSafe™ Flange Clamp. The Clamp design, once fitted, eliminates the possibility of leakage or blowout due to gross failure of the corroded bolts. A number of segments are designed to permanently encase the flange and each segment has a number of preinstalled 'backstops'. This patented feature allows the preloading of the Clamp without any significant Clamp load passing through the parent flange or gasket. The preload is designed to exceed the existing load in the corroded bolts so that in the event the parent bolts fail the gasket sealing stress is maintained.

The MorSafe™ clamp does not require any hydraulics or pneumatics to retain the clamp preload, nor does it increase the load on the gasket. The lightweight and compact design fits almost all flange space restrictions; it is easy to handle and fit, enabling fast and safe deployment.

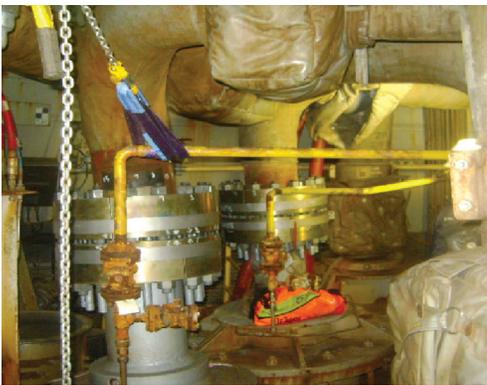
**Below** Hydratight's MorSafe™ 10" CL1500 Flange Clamp solution
