Case Study

MorSafe™ technology extends life of asset

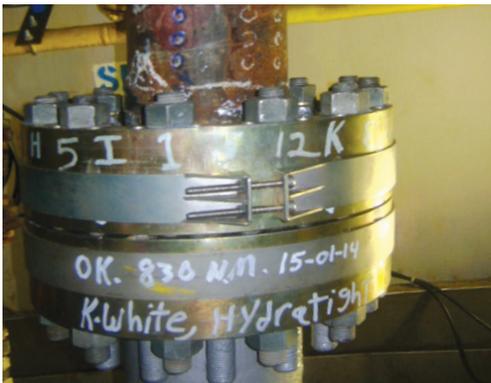
Above Hydratight's MorSafe™ 6" CL1500 Flange Clamp solution

Hydratight provided a simple, safe and secure solution using its MorSafe™ Flange Clamp. The Clamp design, once fitted, eliminates the possibility of leakage or blowout due to gross failure of the corroded bolts. A number of segments are designed to permanently encase the flange and each segment has a number of preinstalled 'backstops'. This patented feature allows the preloading of the Clamp without any significant Clamp load passing through the parent flange or gasket. The preload is designed to exceed the existing load in the corroded bolts so that in the event the parent bolts fail the gasket sealing stress is maintained.

The MorSafe™ clamp does not require any hydraulics or pneumatics to retain the clamp preload, nor does it increase the load on the gasket. The lightweight and compact design fits almost all flange space restrictions; it is easy to handle and fit, enabling fast and safe deployment.

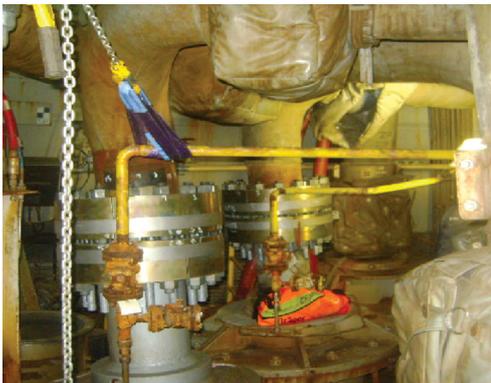
Below Hydratight's MorSafe™ 10" CL1500 Flange Clamp solution
